**MINUTES**  
**Mountain Park Condominiums Owners Association**  
**RoofDeck Engineering Presentation — October 23, 2025**  
**Pool Area — 6:15 - 7:15 PM**

## STRUCTURAL ENGINEERING CONSULTANTS

Subject: 1419 W. Camelback Ln Site Observation – Pool House Roof Framing

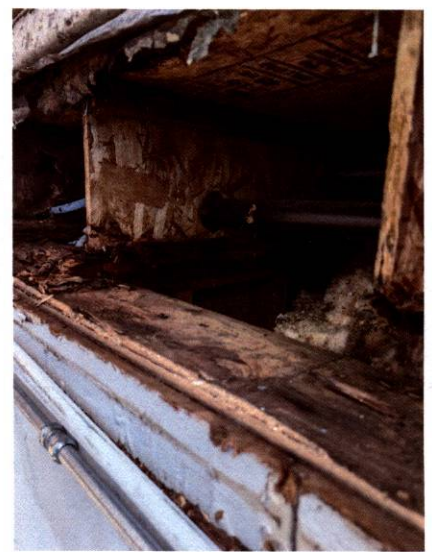
There were several areas visible where there was some level of damage. The joists over the sauna have substantial deterioration of the wood in the bottom flange of the joist at the west bearing end. Finishes weren't removed at the parking side. But what I could see by shining a light to the east bearing end, it appeared that there was no, or much less substantial damage at that end. There are areas of water damage in the south equipment room at the east end joist bearing. The damage is medium level, but enough that the joists in this area should be replaced. Bearing capacity of these joists at the retaining wall is clearly reduced. Joists at the north and south end of the sauna that continue out to the covered area deck have webs that have completely rotted away. This will require opening up and replacing some of the framing outside of the pool house into the covered area framing. It was not easy to view from my angle, but any wall plate that is water damaged and has rot at joist bearing should be replaced with new solid bearing wood material.

**JOIST BEARING DAMAGE AT SAUNA**

Going forward obviously the deteriorated bearing at the joists needs to be dealt with. This will involve removing areas with bad joists and replacing them. This is a little difficult due to the existing plumbing in the roof structure. But there is no good way to splice a new section on to an existing wood joist. I recommend seriously considering full removal of the concrete layer. This will allow you to inspect for other areas that have suffered deterioration so you can make repairs as needed. This will also allow you to work with a waterproofing contractor to install a complete system, that is well thought out and works as a total system. Water in continuous contact with wood structures is the most sure fired way to cause structural damage. It also seems to me that high humidity from the sauna has accelerated deterioration at this area. Investigation of how to properly exhaust humidity from the sauna to prevent future damage could be prudent. Also, it would be wise to investigate topping systems that are an alternative to concrete. Concrete is a great wear surface, but you can count on it cracking and allowing future water intrusion onto the new waterproof membrane.

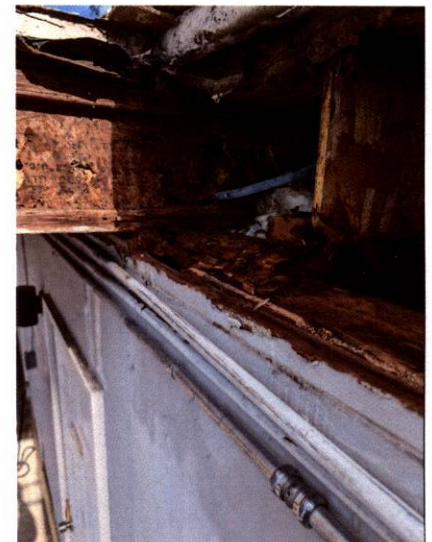
**JOIST WEB DAMAGE AT SAUNA NORTH SIDE**

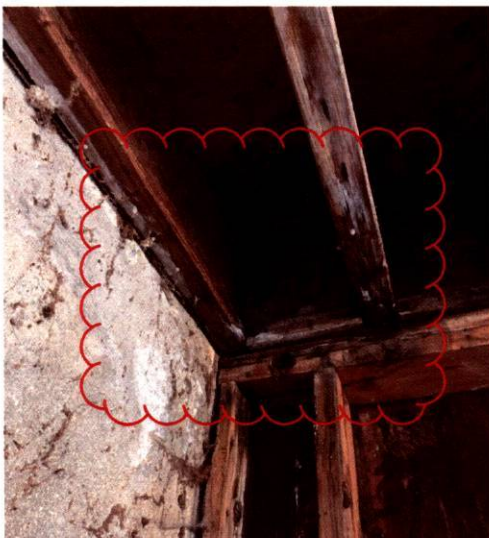
**JOIST BEARING DAMAGE AT INTERIOR**

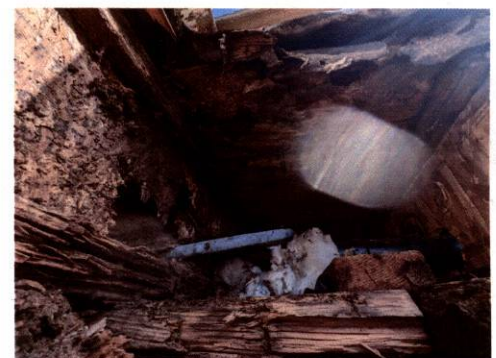
**DECK, WEB, AND PLATE DAMAGE AT SAUNA**
